Karditsa, Greece / 14th July 2017

Department of Wood & Furniture Design and Technology

Laboratory of Wood Science & Technology

TECHNICAL REPORT

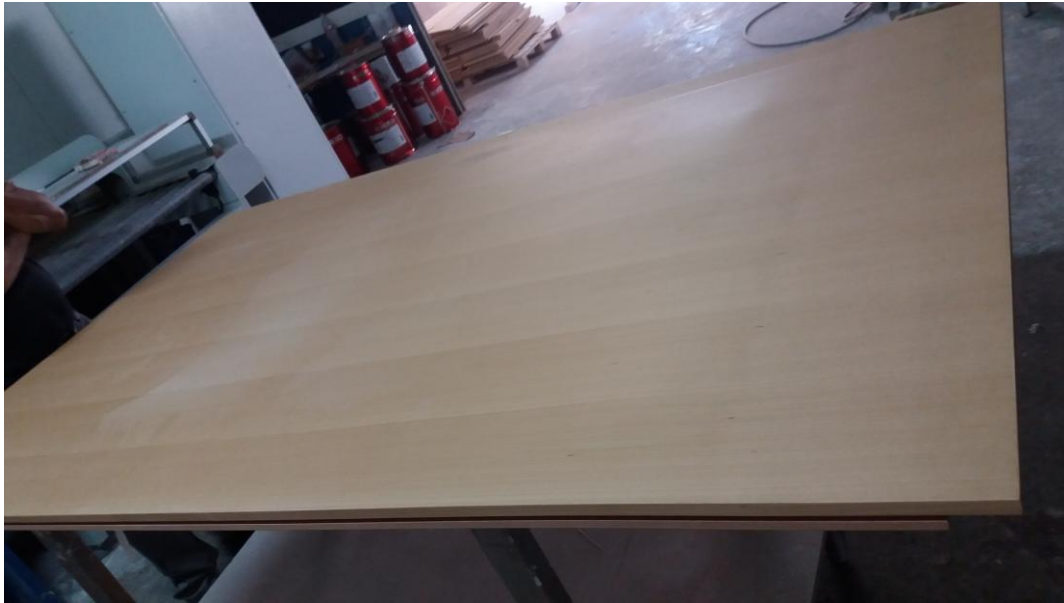
Photo 1. Photography of one acoustic panel examined on site by Dr. G. Mantanis
(photo taken by Dr. George I. Mantanis)

For that, I visited in person that company on the 5th of July 2017, and examined thoroughly samples of acoustic panels which were shown to me by representatives of [REDACTED]. As a matter of fact, I inspected two acoustic panels ([photo 1](#)) which were composed of 16mm-thickness honeycomb panels, layered with steamed beech veneers. According to [REDACTED] claim, these were commercial products of [REDACTED], a company based in [REDACTED].

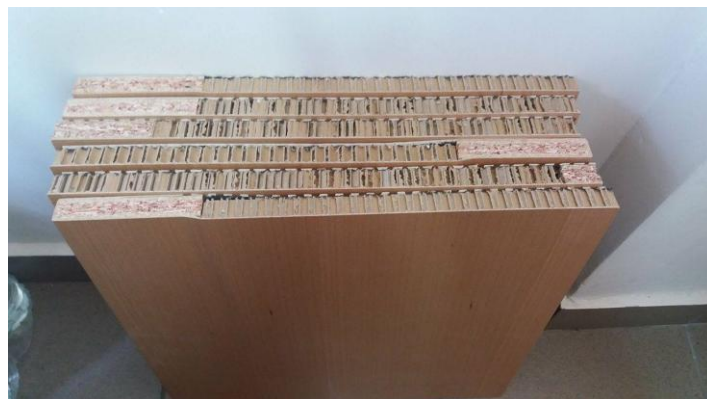
Photo 2. Photography of the small panel samples collected by Dr. G. Mantanis
(photo taken by Dr. George I. Mantanis)

I collected small samples ([photo 2](#)) from the two acoustic panels which I brought them at my lab, *Laboratory of Wood Science and Technology* in Karditsa city, Greece (TEI of Thessaly) to further examine, and investigate them macroscopically.

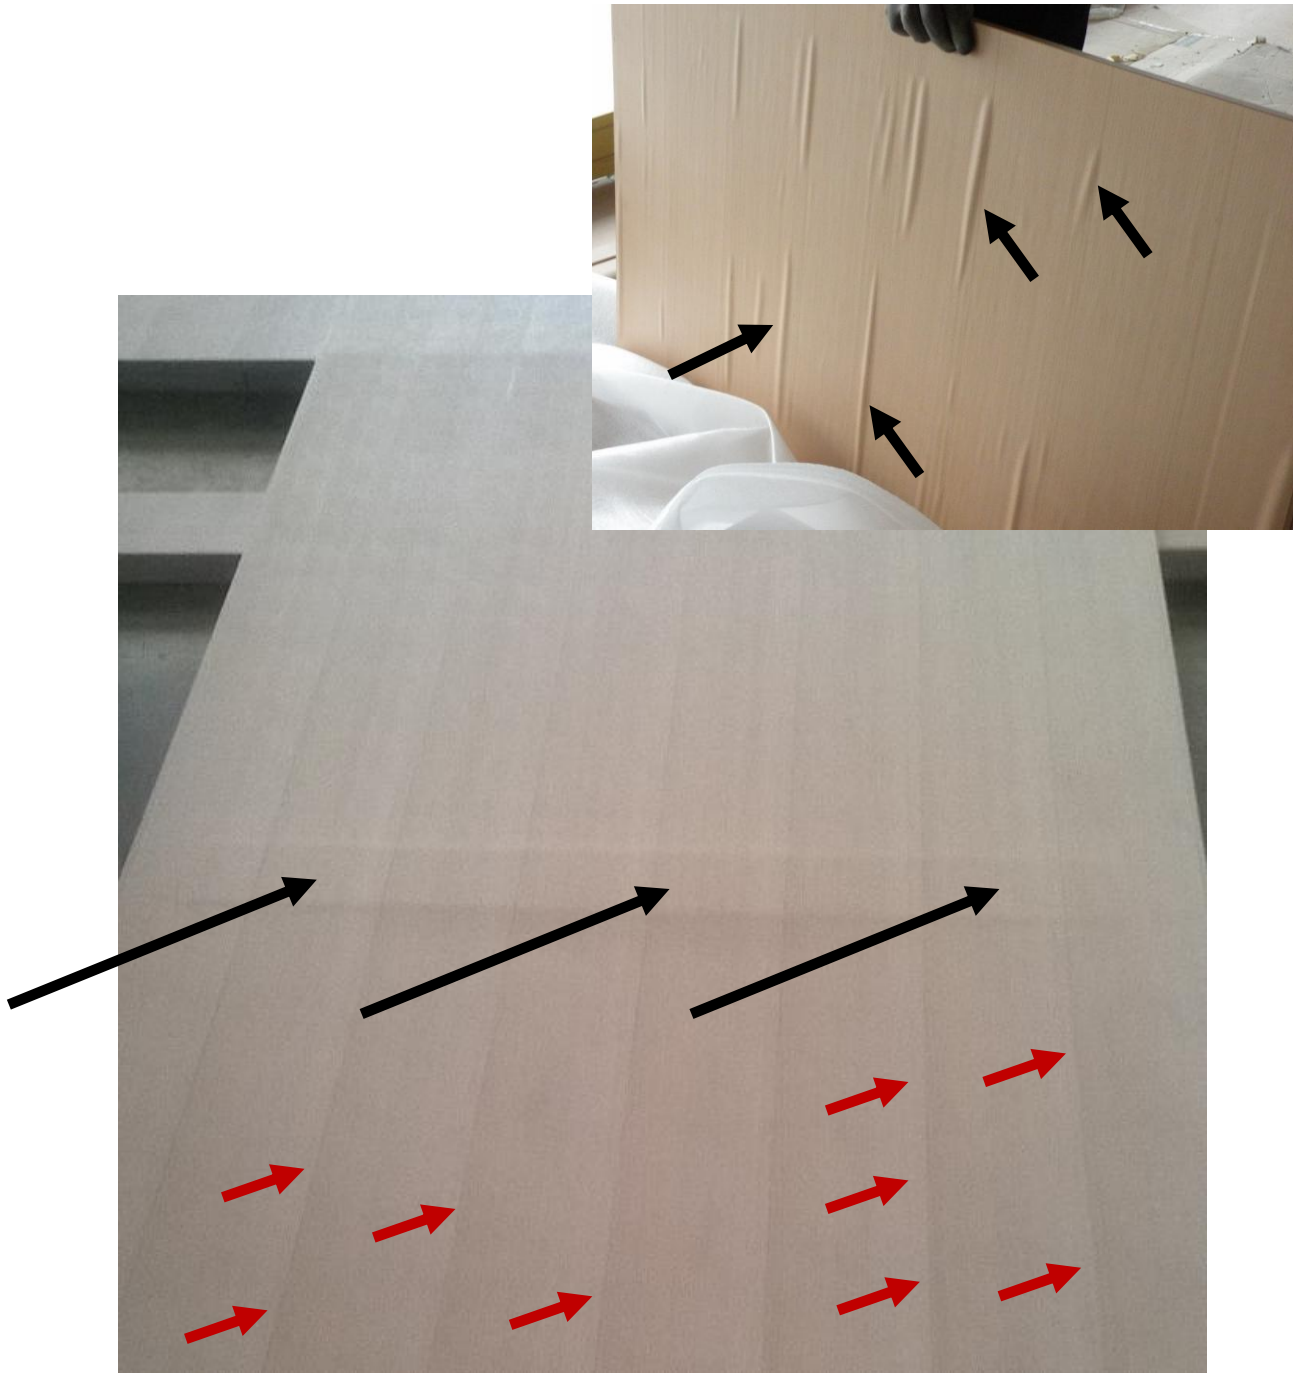
Photos 3a – 3b (photos taken by Mr. [REDACTED])

In the photos, one can clearly see the 'swollen surfaces' occurred in acoustic panels.

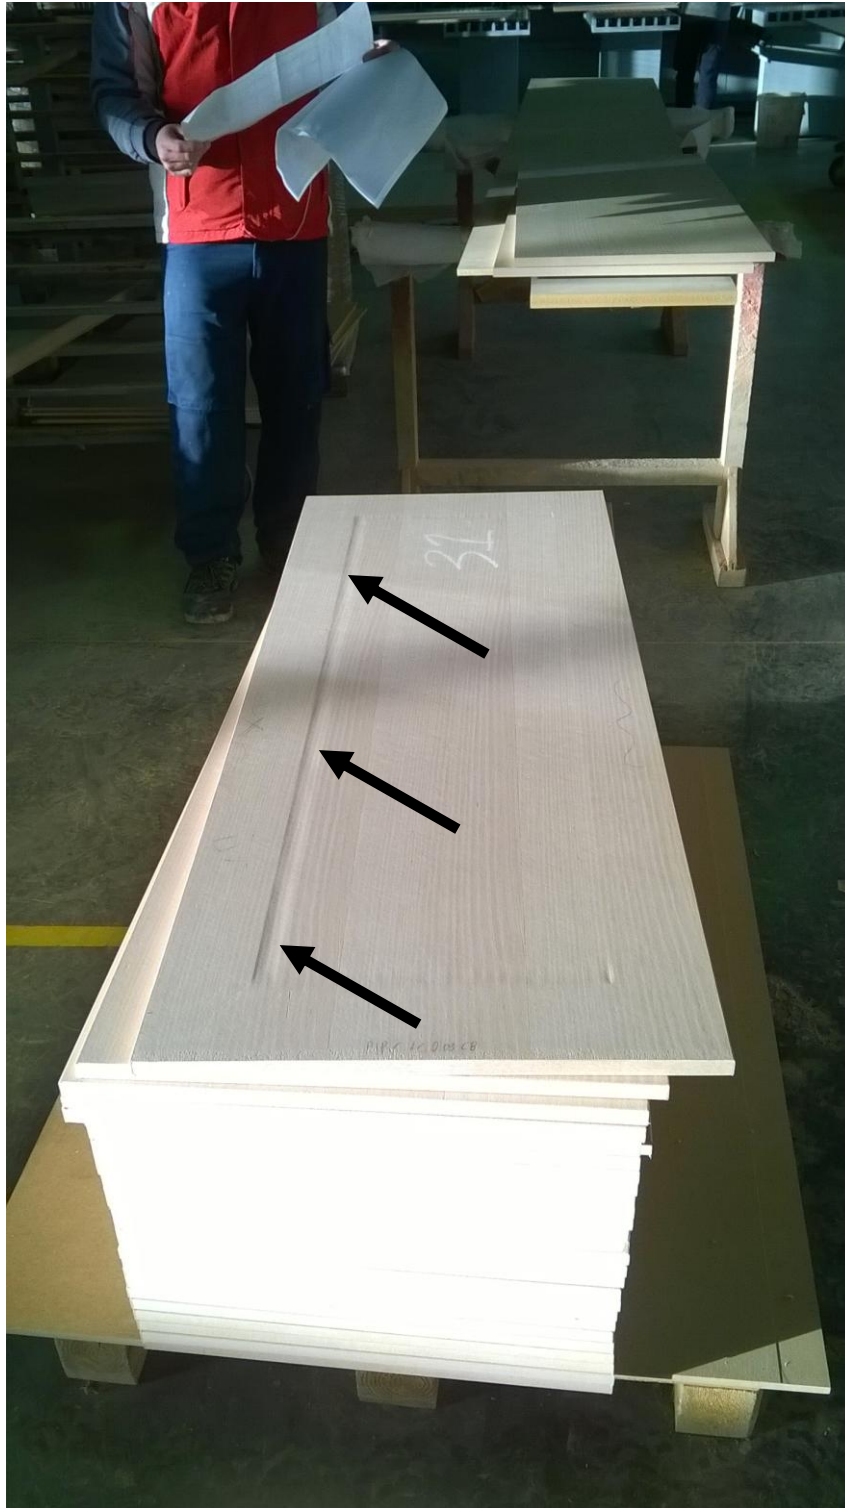
Photo 4 (photo taken on 16th Jan. 2017 by [redacted])

In this photo, this acoustic panel has been undergone a 'channel defect' making it problematic for final use in high-quality wall covering.

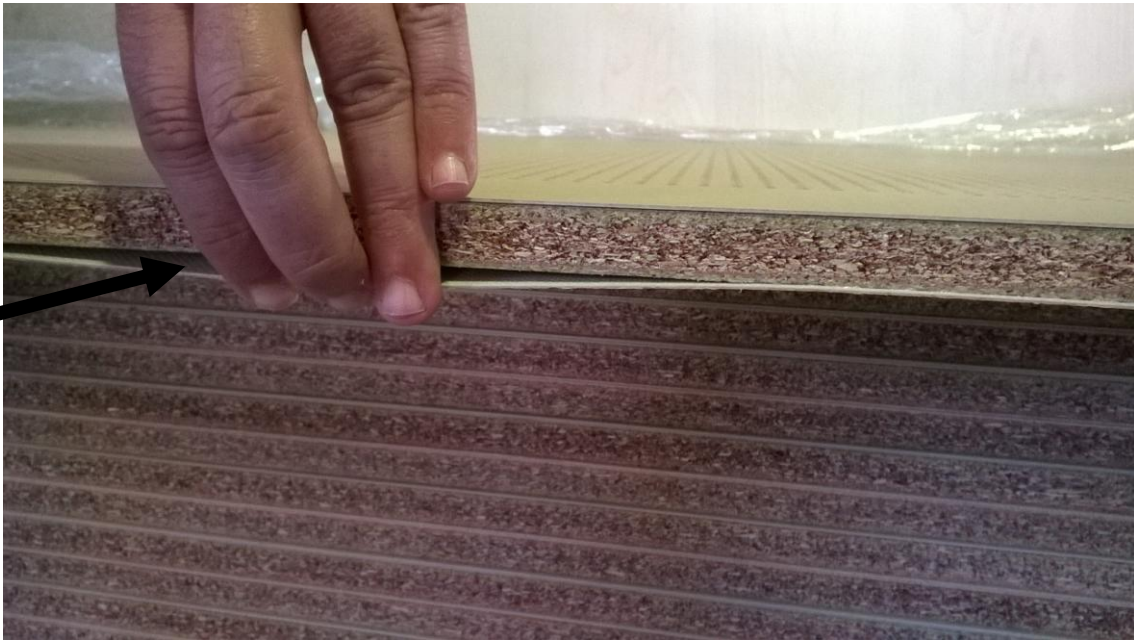
Photo 5 (photo taken on 01st Feb. 2017 by [REDACTED])

From the photos no. 3-6 ([REDACTED]), which were sent to me by e-mail, one can see several defects e.g., *uprising parts, channels, delaminations*, that occurred in the acoustic panels. From photos 5 and 6, it may be concluded that inappropriate gluing of the beech veneers to the particleboard substrate has resulted in some partial or full delamination (photo 6a), a serious defect.

In this photo, as seen, a veneer glued to FR-board has been **partially delaminated**, a defect of delamination in such panel is a serious one.

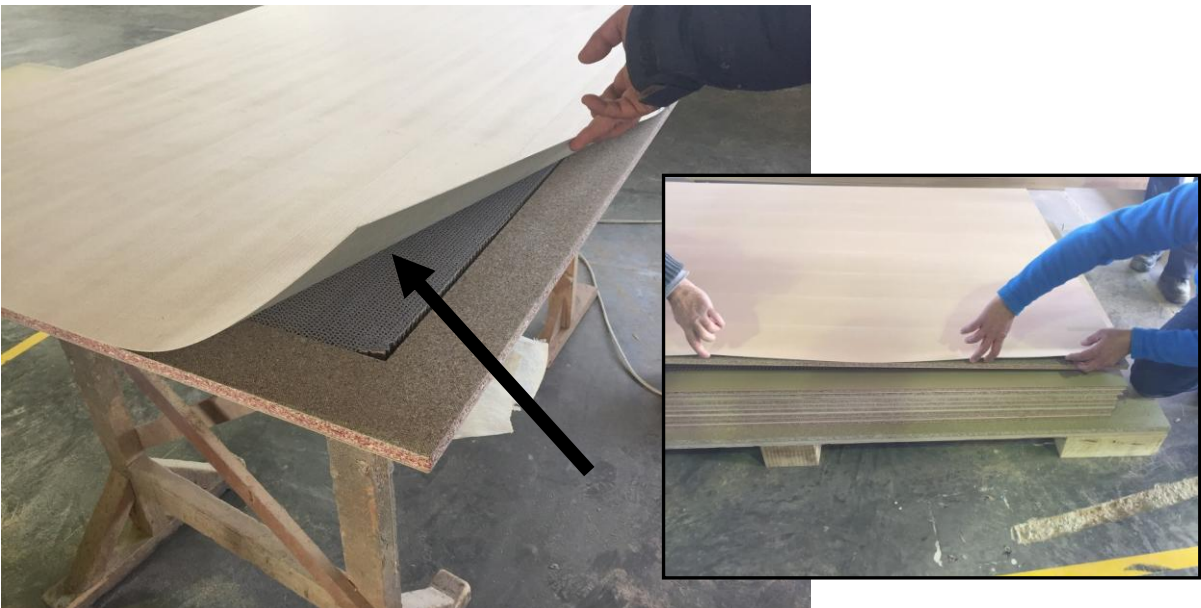
Photos 6a - 6b (photos taken on 01st Feb. 2017 by [REDACTED])

Two other acoustic panels (as delivered in the 2nd batch) has been undergone a **full delamination** in the edges, possibly due to erroneous gluing.

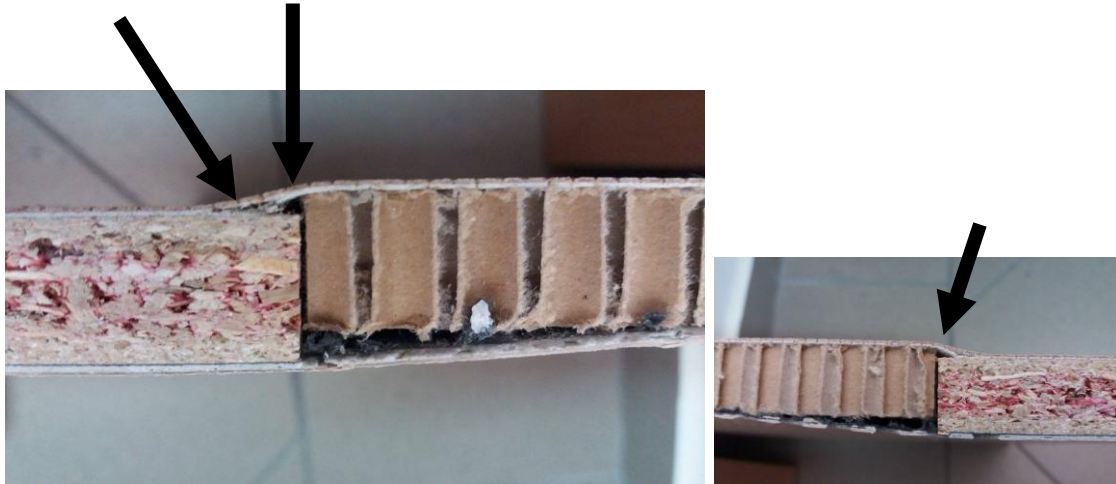
My findings from the examination of the acoustic panels, as done on site at the company, is that at least 5 or 6 local 'swollen surfaces' existed upon the panels (see photos 7-8). By my hands, it was apparent that veneers locally had been risen up (during the shipping); 'pop-ups' were at least 3 or 4 mm in height (photo 8). The situation was the same in both panels. Such defects **mostly** happened in the *connection area* between honeycomb and particleboard frame, and **deteriorated significantly the quality of the acoustic panels**. This finding was verified by my personal examination taken place at TEI of Thessaly, in Karditsa (photos 7 & 8), on 14/07/2017.

Photos 7a – 7b (photos taken by Dr. George Mantanis at the TEI of Thessaly)
In the photos, it is very apparent the structural defects, right in the *connection areas*, that been taken place in the acoustic panels, i.e. defects very difficult to solve.

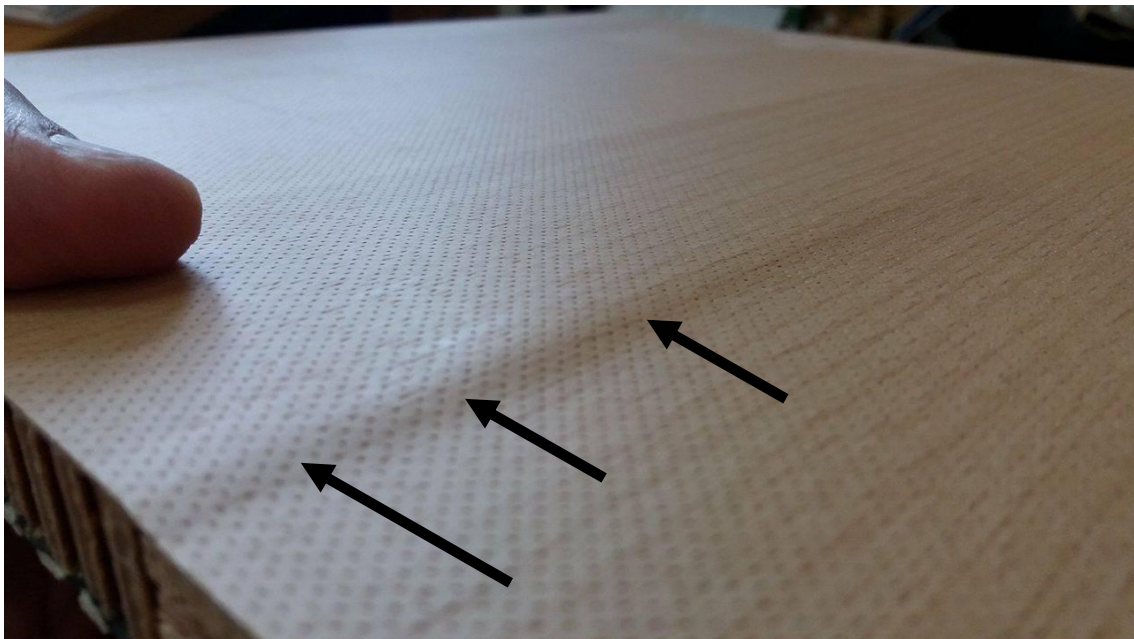
Photo 8 (photo taken by Dr. George Mantanis at the TEI of Thessaly)
In the photo, it can be seen the structural defects of local 'swollen surfaces' (like a 'layer') taken place in a acoustic panel.
