# WEATHERING TEST OF FURFURYLATED WOOD DECKS IN A 3-YEAR EXPOSURE IN GREECE

**COST Action FP1303** – 1<sup>st</sup> Conference, 'Performance and maintenance of bio-based building materials influencing the life cycle and LCA', Kranjska Gora, Slovenia, 23 & 24 October 2014

In this work, a **three-year natural weathering test** of **furfurylated wood decks** was carried out in Greece.

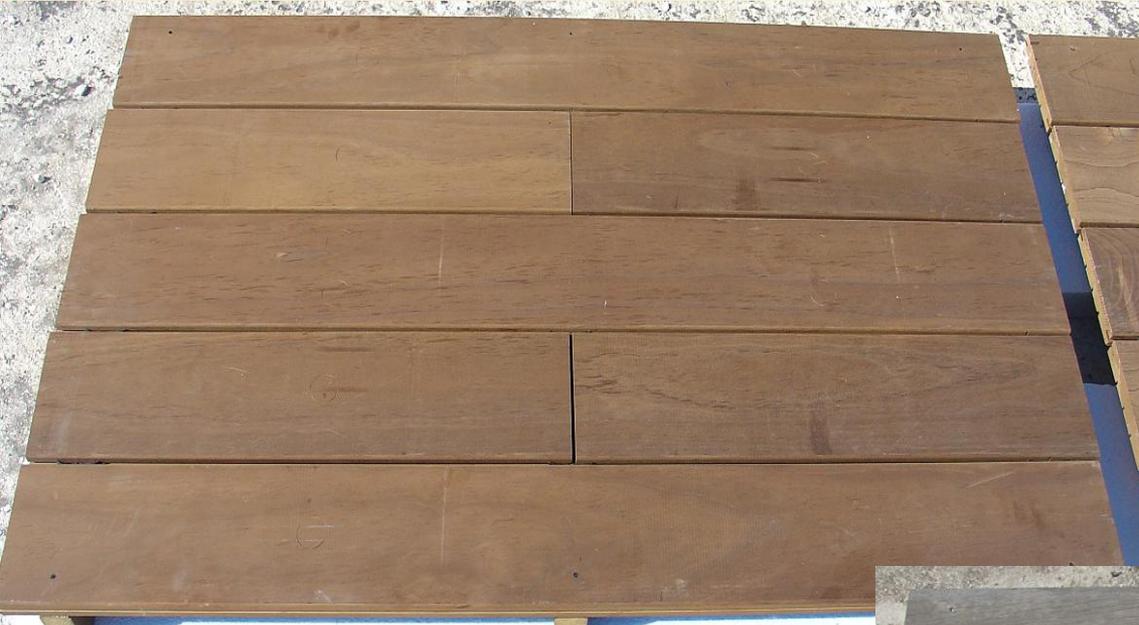
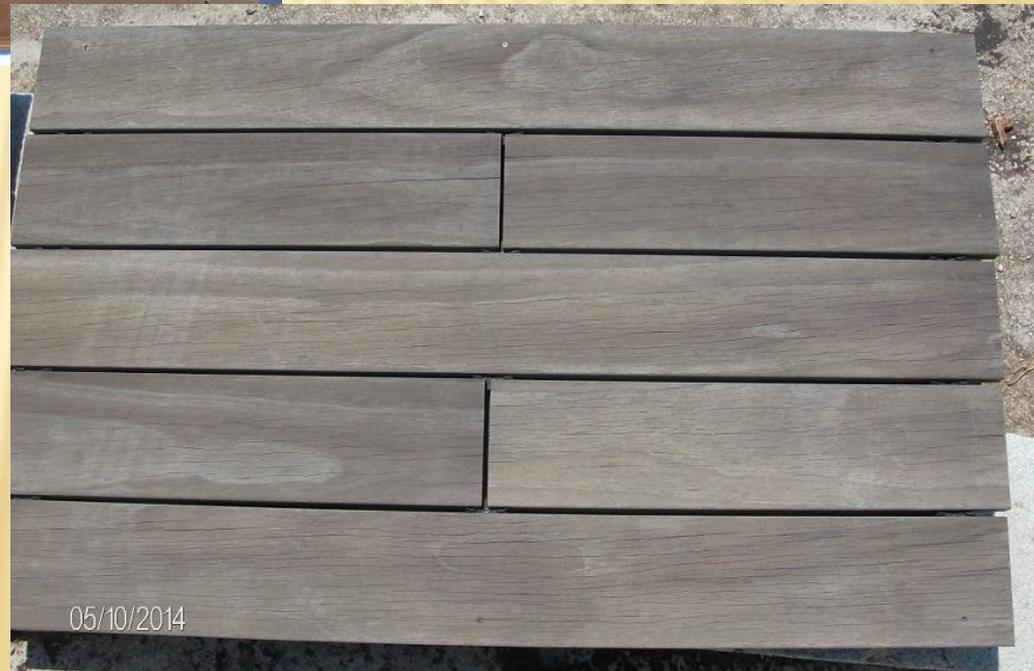
**FF R. Pine (as in May 2014)**

- × All decks tested exhibited an extensive **greying effect** in their surfaces.

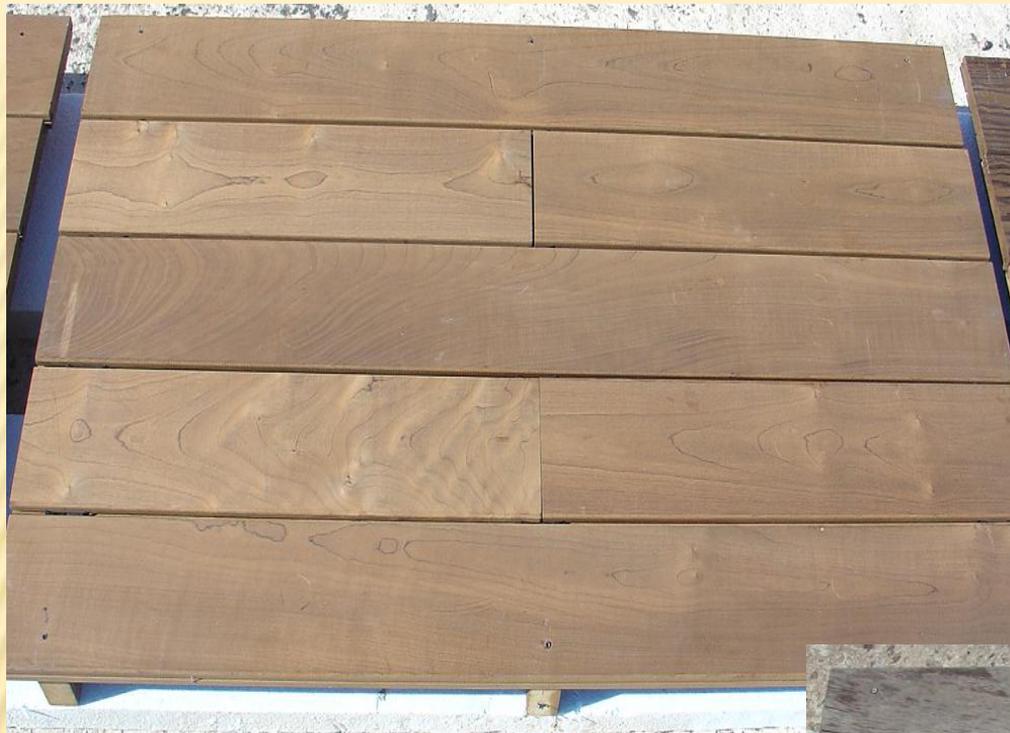
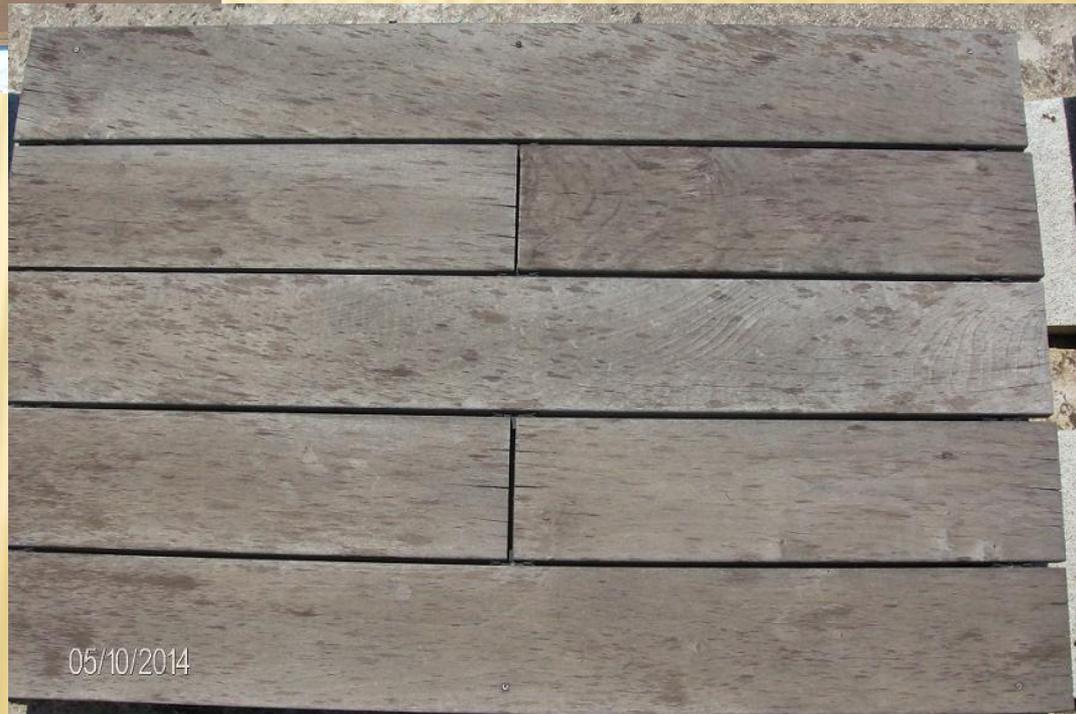
**FF Maple (as in May 2014)**

- ✘ **No black staining** - except for the FF Maple decks which showed some mild **shadow spots** on wood surfaces.

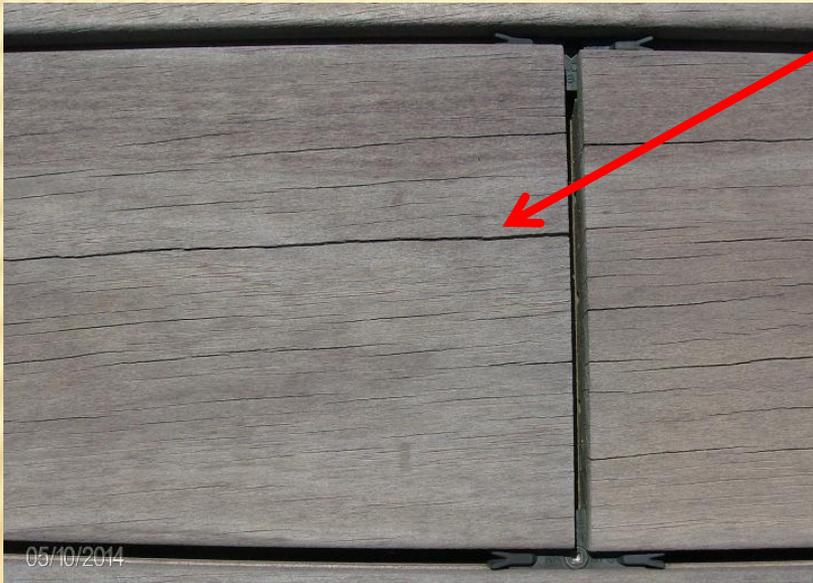
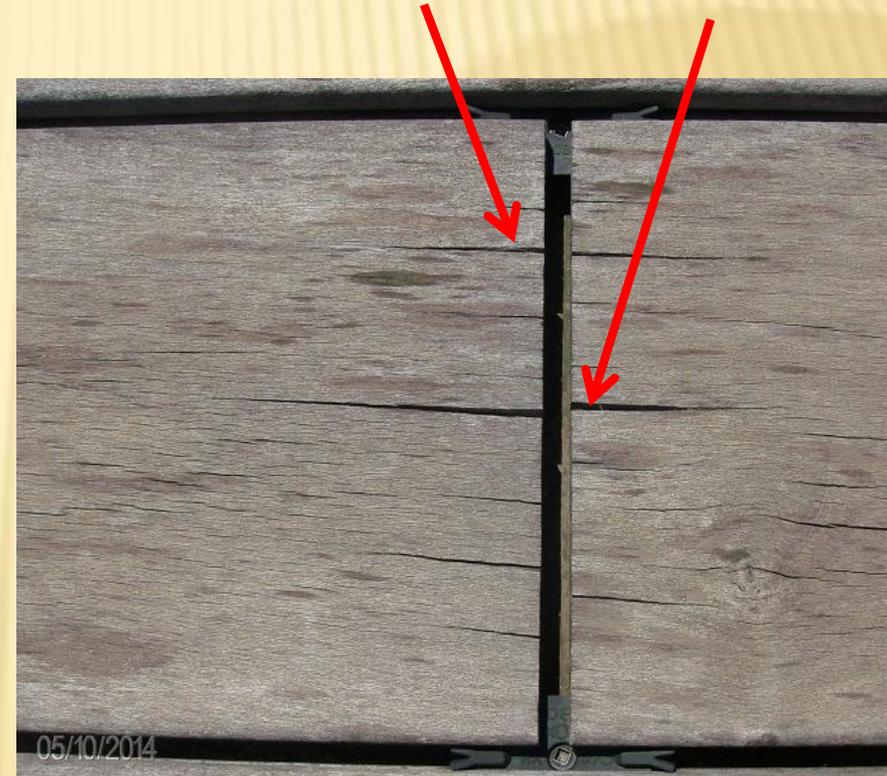
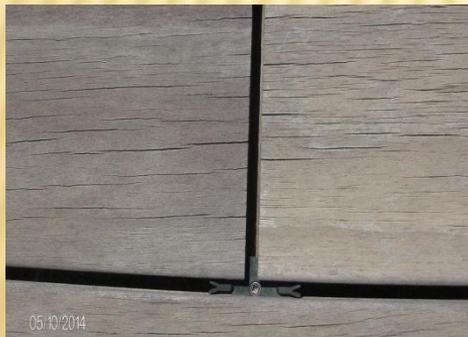
- × **Ipê wood** deck showed to have the minimum number of cracks on its surface, closely followed by the Radiata pine wood deck which had only a very few small cracks.

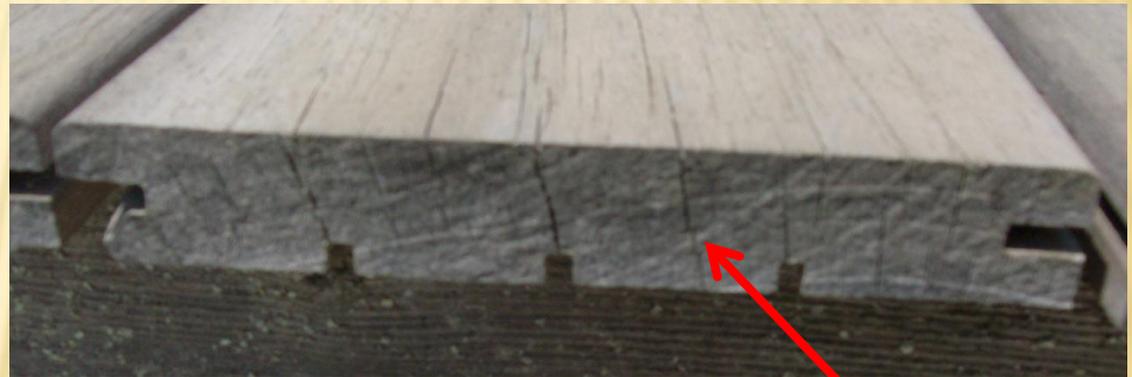
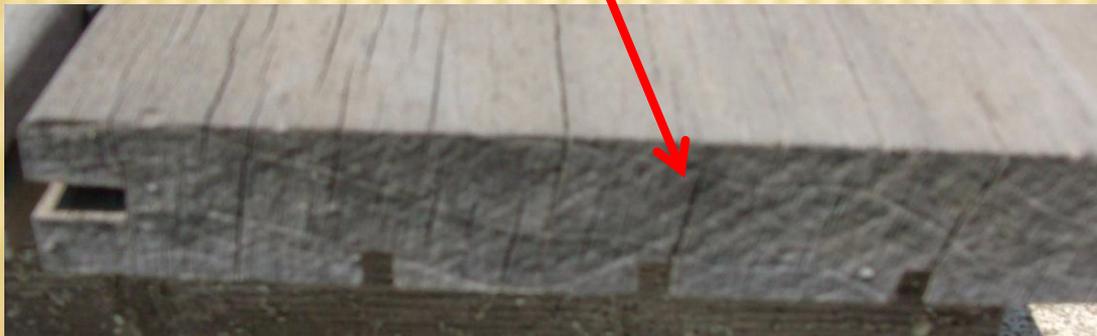
FF Radiata Pine decks

A) It appeared that the furfurylated **Radiata pine decks** showed the **mildest end-splitting**

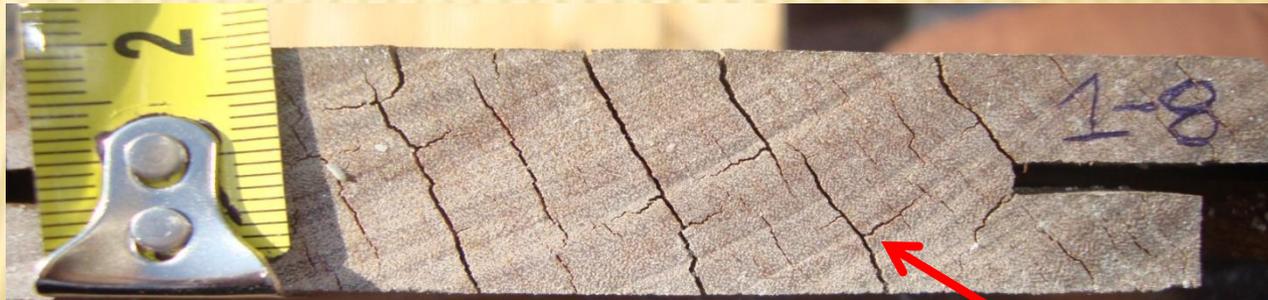
Control Ipê wood decks

B) The control **Ipê decks** showed some degree of **end-splitting**

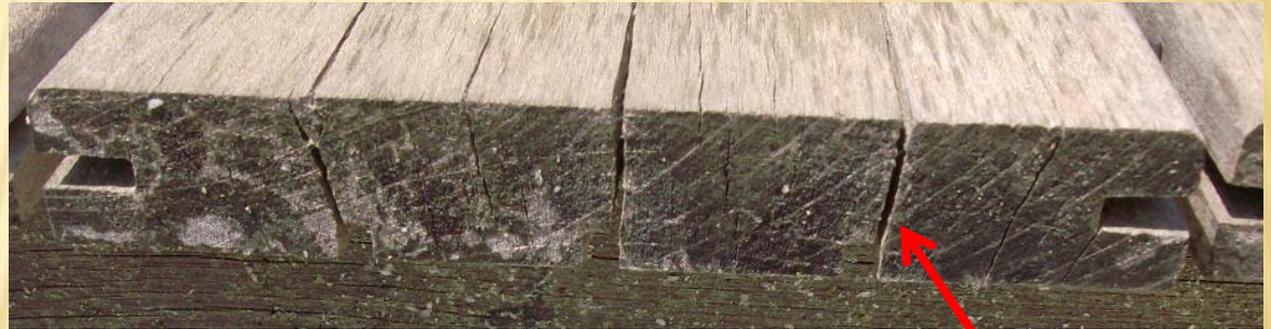
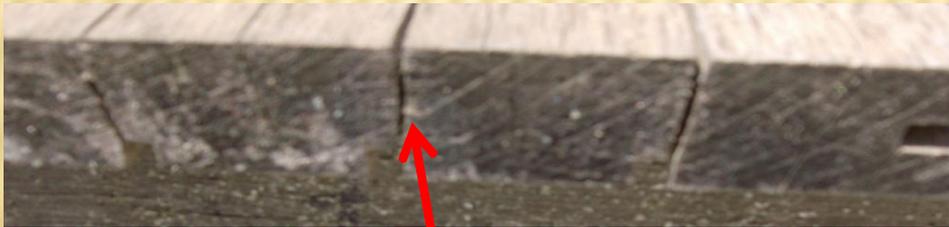
FF Maple wood decks

C) It appeared that the furfurylated **Maple wood decks** showed a **higher degree** of end-splitting
