Structural Evaluation of a Timber Construction Element Originating from the Great Metéoron Monastery in Greece

This study identified the wood species and evaluated the degree of weathering and biological degradation of a historical timber construction element originating from the Great Metéoron monastery in Metéora, Greece. The wood material was provided from the interior side of a balcony that was fully covered with a roof and exposed to outdoor conditions for more than 400 years. The species was identified as *Quercus* spp. of the white oak group. In the timber element, the physical, morphological, and chemical changes were studied to assess the type and extent of degradation using light microscopy and Fourier transform infrared (FT-IR) spectroscopy. To examine the degree of biological degradation and weathering, the surface layer and inner parts of the specimen were studied separately and compared with a recent wood specimen of the same species. The FT-IR analysis revealed remarkable differences between the surface layer and the inner parts of the historical wooden element. Macroscopic and microscopic investigation indicated that multiple types of degradation caused by weatheri

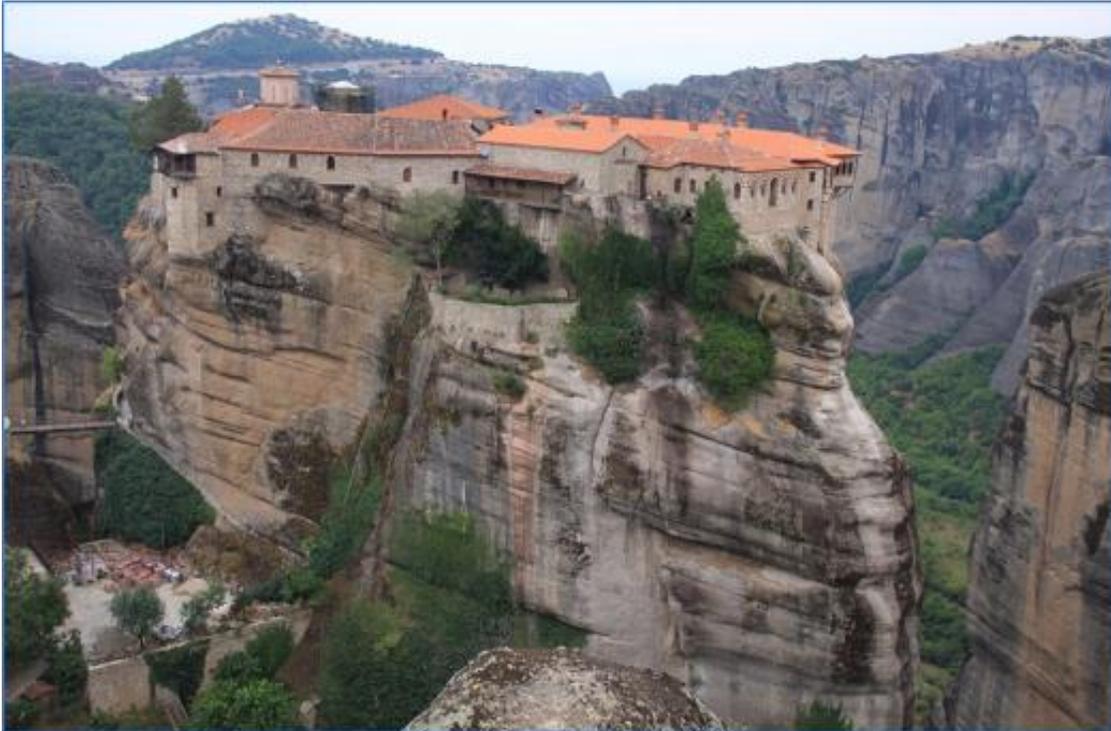
Fig. 1. Great Metéoron monastery in Metéora, Greece (photo by G. Mantanis)

Metéoron monastery was founded in the middle of 14th century A.D. (Fig. 1). A large number of structural timber elements, primarily from the oak and chestnut species, along with wooden floors, roofs, and timber-framed walls are still standing in the monastery (Tsakanika 2007). Most timber elements need thorough conservation and restoration due to the very extensive weathering and biological degradation they endure (Paggitoulis 2007).

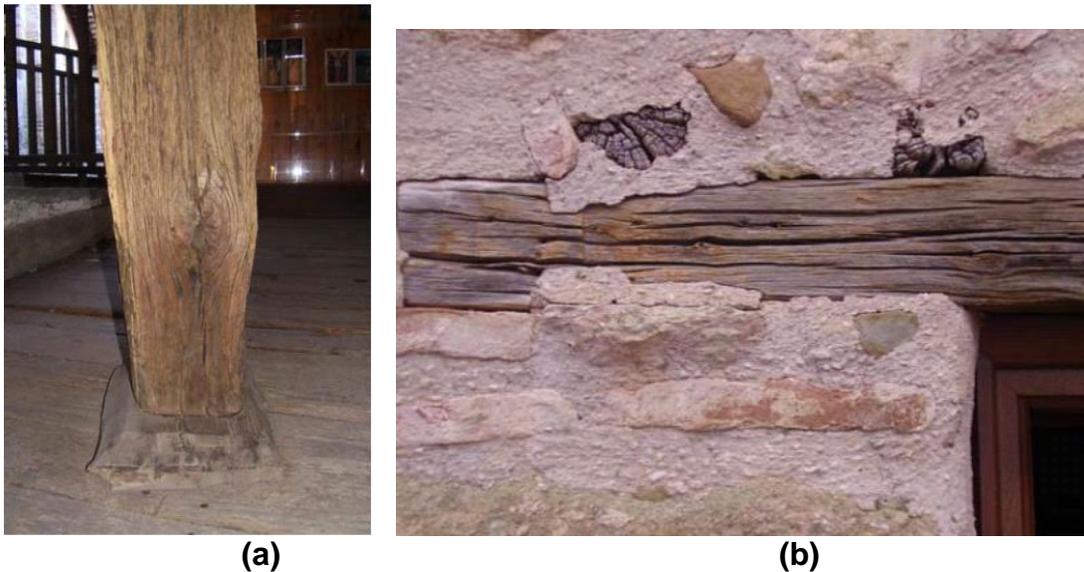
Fig. 2. An old timber column (a) and a timber-framed wall element (b) in the Great Metéoron monastery, Metéora, Greece (Paggitoulis 2007)

A recent study respecting the Metéora wooden structures by Paggitoulis (2007) revealed that many of the wooden columns have suffered all types of surface degradation (fungi attacks, insect wormholes, checks, and deterioration due to weathering). The timber samples collected were kept at WFDT in a dry room, at normal climatic conditions, and never came in contact with water or other damage.

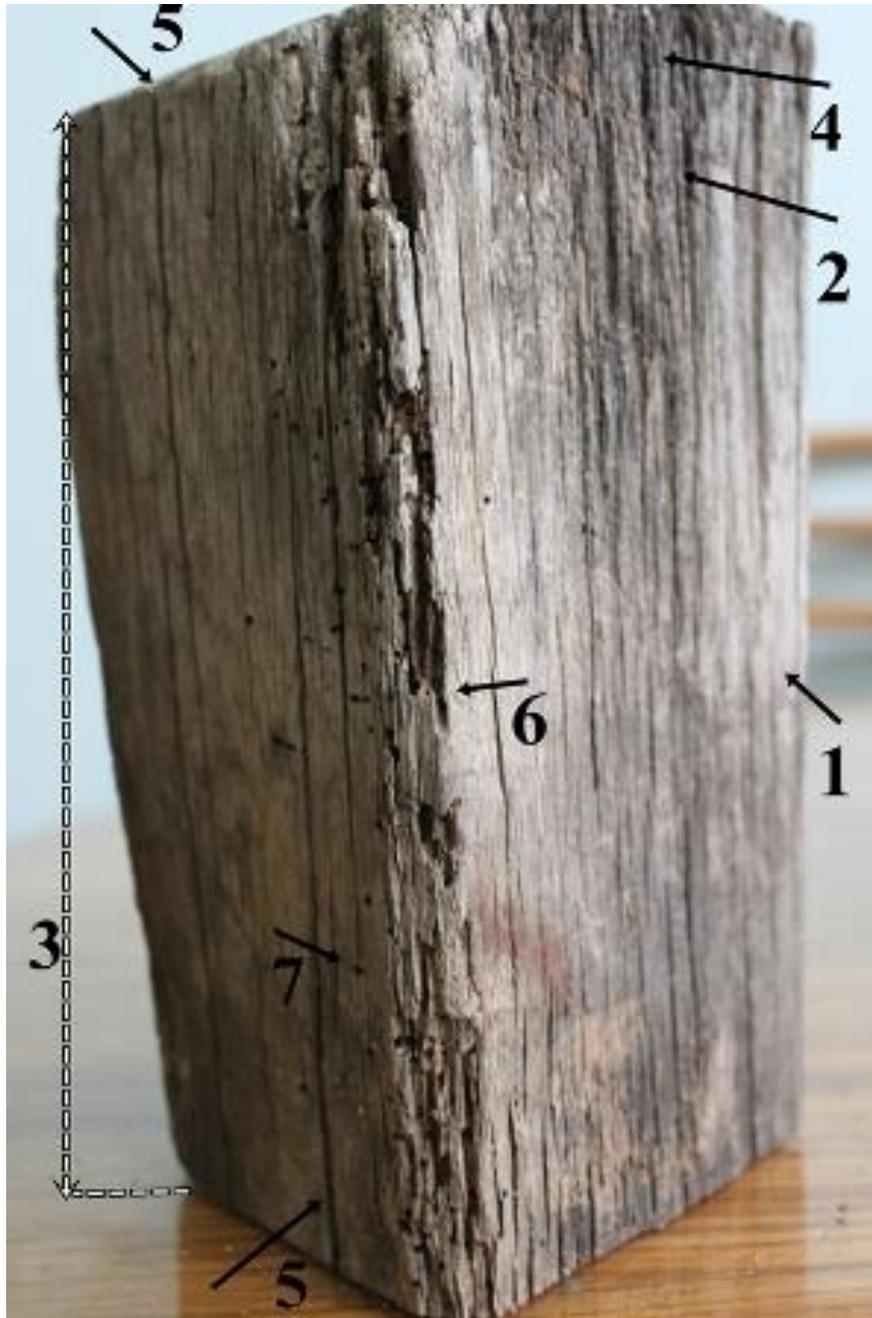
Fig. 3. Macroscopic view of the longitudinal surfaces of the old wood sample. The wood surface in silver gray (1), and darkish gray (2) color, asymmetrical wood structure (3), slightly eroded wood fibers (4), checks in wood surfaces (5), small voids (6), and insect bore holes (7) in the wood structure

In general, the surface of the old wood sample had silver gray and darkish gray colors (Figs. 3 through 5). The integrity of the surface was lost, and it looked like a charred structure (Figs. 3 through 5).

The sample was in a rather asymmetrical structure, while splits and checks were observed in all of the element surfaces (Figs. 3 through 5). In addition, a checkered appearance was noted at the transversal surface (Fig. 4). Slightly eroded fibers were also observed on the wood surfaces (Figs. 3 and 4).

In this study, cubical cracks and small voids, brown discoloration, fragile structure, and block shrinkage were observed along the two longitudinal corners of the old wood specimen (Figs. 3 through 5). A cottony white growth in the surface of wood was considered a fungal activity (Fig. 5). While the heartwood saved its natural color, the color of sapwood changed to brownish (Fig. 6). Those changes indicated that brown-rot decay might have occurred. The macroscopic signs of wood decomposition could be regarded as the decay in the intermediate stage (Feist 1990; Anthony 2007). In addition to decay, insect boreholes were notably detected in the zone where the brown-rot decay occurred (Fig. 3).

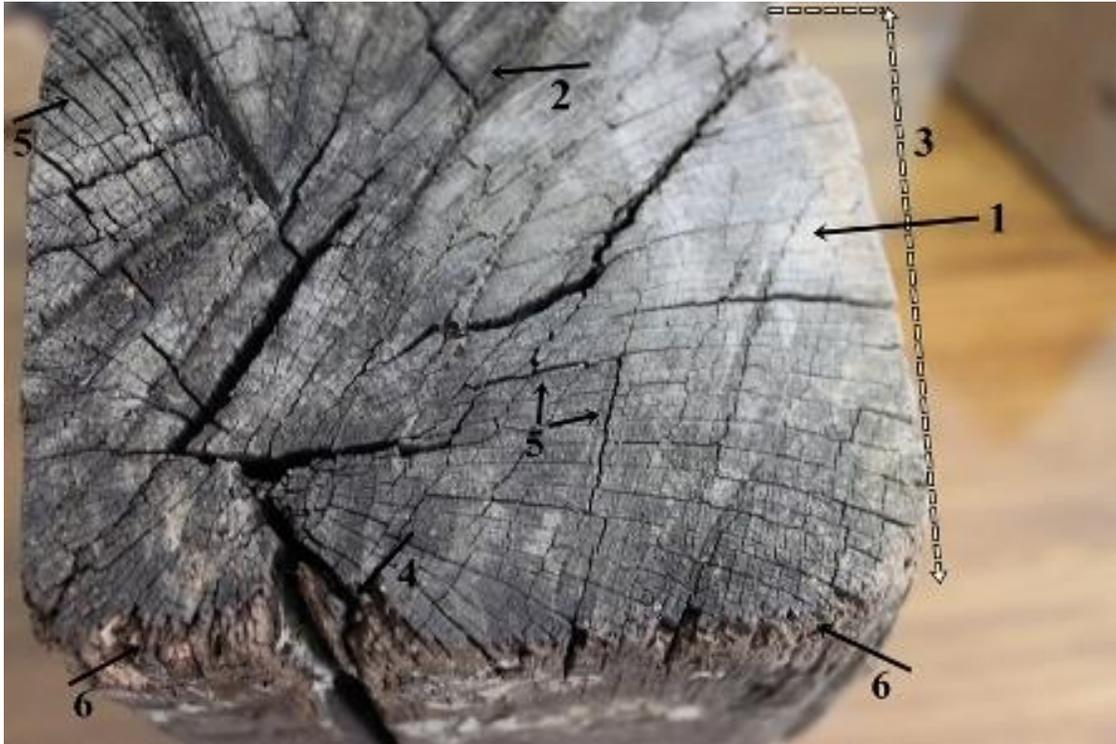
Fig. 4. Macroscopic view of the transversal surface of the old wood sample: Wood surface in silver gray (1) and darkish gray (2) color, asymmetrical wood structure (3), splits (4) and checks (5) in the wood structure, and slightly eroded wood fibers in the surface of the wood element (6)

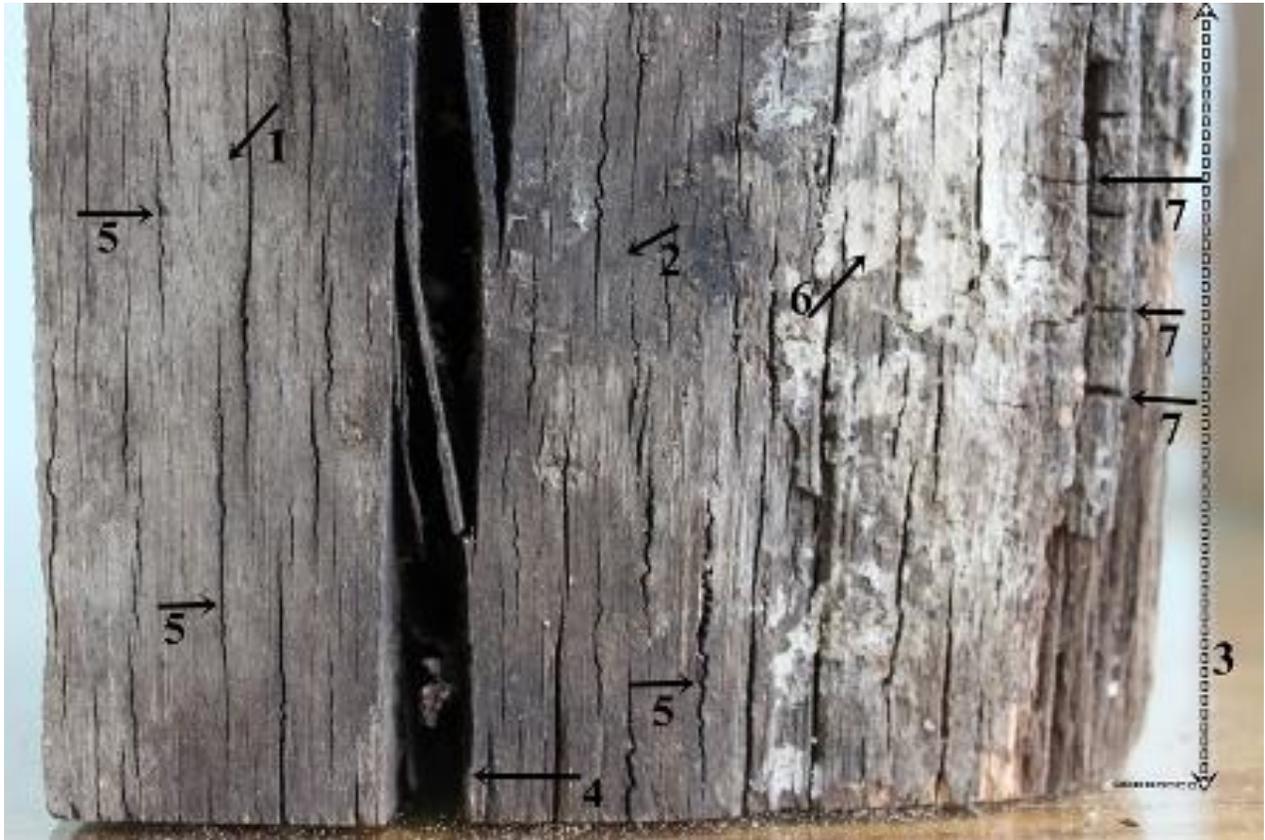
Fig. 5. Macroscopic view of the longitudinal surface of the old sample: Wood surface in silver gray (1) and darkish gray color (2), asymmetrical wood structure (3), splits (4) and checks (5) in the surface, a cottony white growth on the wood surface (6), and cubical cracks in the wood structure (7).

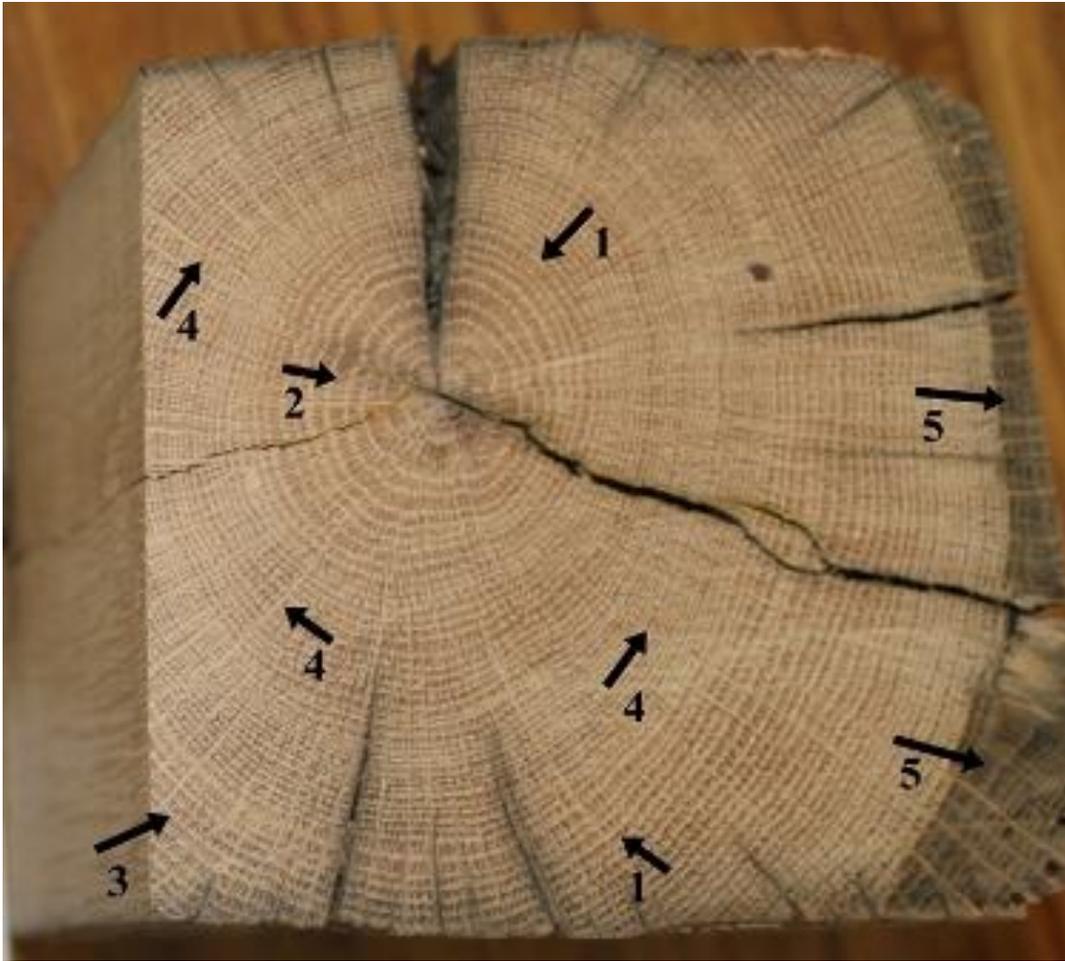
Fig. 6. Macroscopic view of the inner parts of the wood cross-section: Distinct growth ring boundaries (1), ring-porous wood structure (2), latewood vessels (pores) in radial/diagonal to dendritic patterns (3), large rays (4), and color change in sapwood (5)

The wood sample had distinctive combinations of anatomical features at the macroscopic level; therefore, it was easy to identify it from the cross-section (Fig. 6). In particular, the growth ring boundaries were distinct. It was a ring-porous species, and the latewood vessels were in a radial/diagonal to dendritic patterns. These vessels were numerous and indistinct, which were impossible to view and count individually, and the rays were large (Hoadley 1990; Wheeler and Baas 1998). In accordance with these anatomical features, the wood species was recognised as *Quercus* spp. (oak wood) of the white oak group.

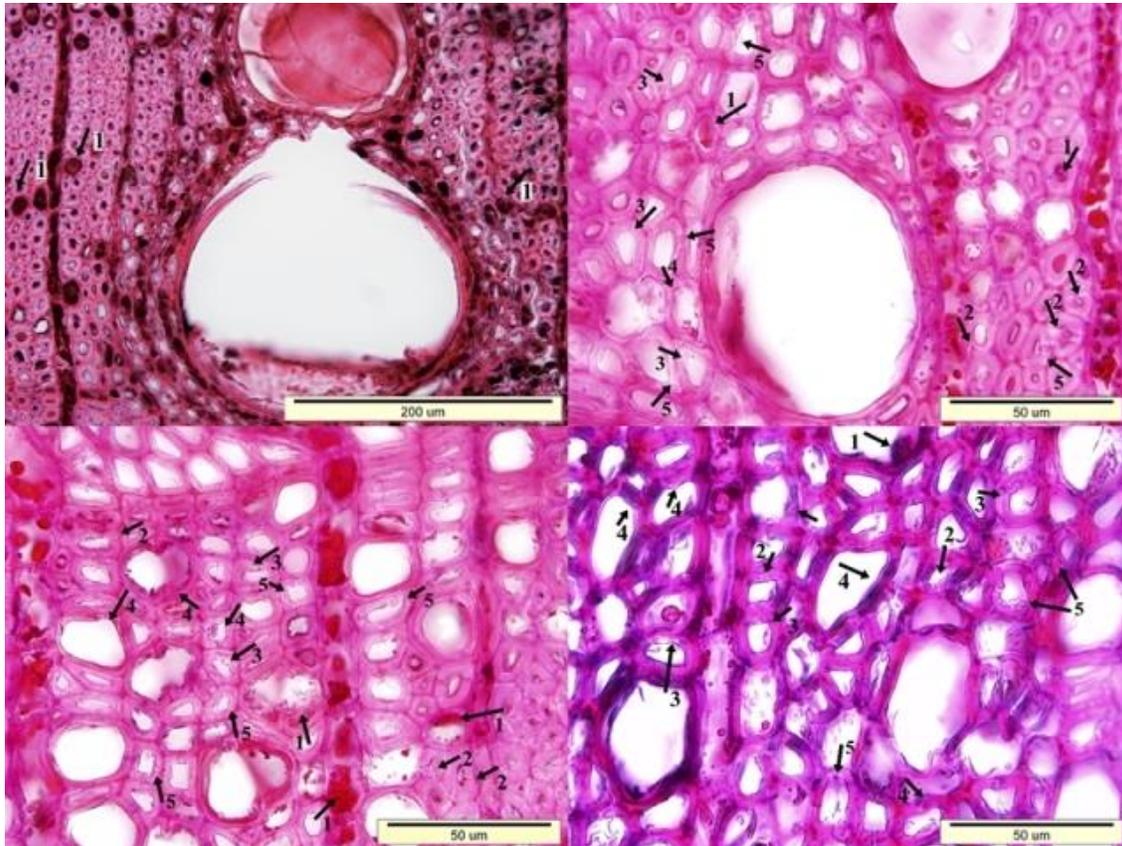
Fig. 7. Microscopic view of the cross-section of the sapwood sample: Dark colored residual materials in the lumen side of wood cells (1), clefts in the secondary walls of fiber cells (2), porous and swollen appearance in the fiber cell walls (3), distortion in the shape of the wood cells (4), and a much more degraded S₂ layer of fiber cell walls (5)

Microscopic evaluations revealed that sapwood/heartwood and earlywood/latewood samples were not different in terms of fungal degradation degree and decay pattern (Figs. 7 and 8). In fact, observations such as: a) the distortion in the shape of the wood cells, b) porous and swollen appearance particularly in the cell walls of fibers, c) much more degraded S₂ layer of fiber cell walls, d) dark colored residual materials in the lumen side of some cells, e) numerous clefts in the secondary walls of fiber cells, and, f) loss of birefringence were evaluated as clear indicators of brown-rot decay (Figs. 7 through 9). This is in agreement with previous reports (Wilcox 1968; Blanchette 2000; Blanchette 2003).

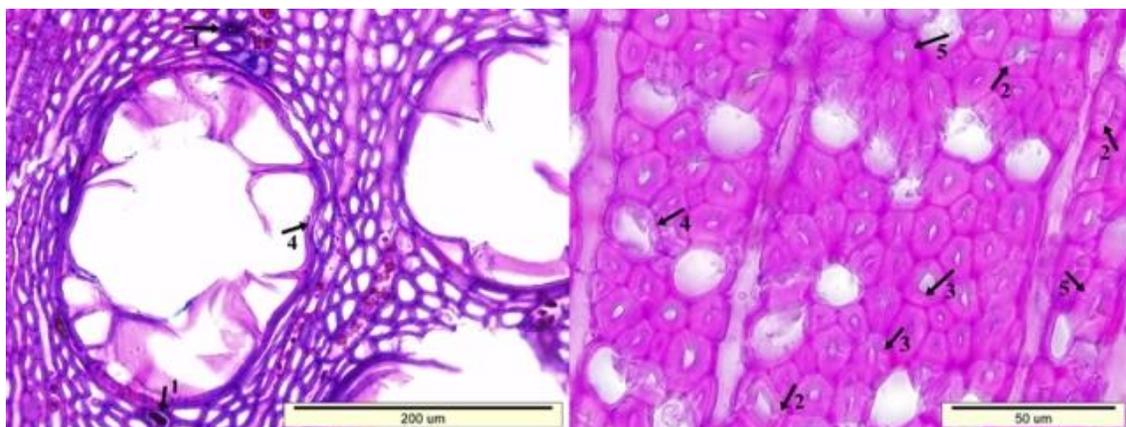
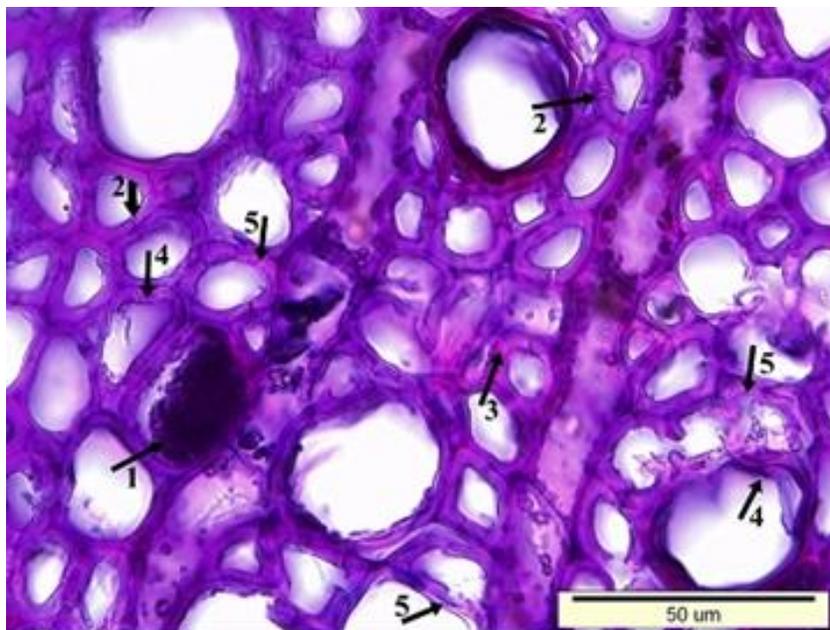
Fig. 8. Microscopic view of the cross-section of the heartwood sample: Dark colored residual materials in the lumen side of wood cells (1), clefts in the secondary walls of fiber cells (2), porous and swollen appearance in the fiber cell walls (3), distortion in the shape of the wood cells (4), and a much more degraded S₂ layer of fiber cell walls (5)

Fig. 8 (continued). Microscopic view of the cross-section of the heartwood sample: Dark colored residual materials in the lumen side of wood cells (1), clefts in the secondary walls of fiber cells (2), porous and swollen appearance in the fiber cell walls (3), distortion in the shape of the wood cells (4), and a much more degraded S₂ layer of fiber cell walls (5)

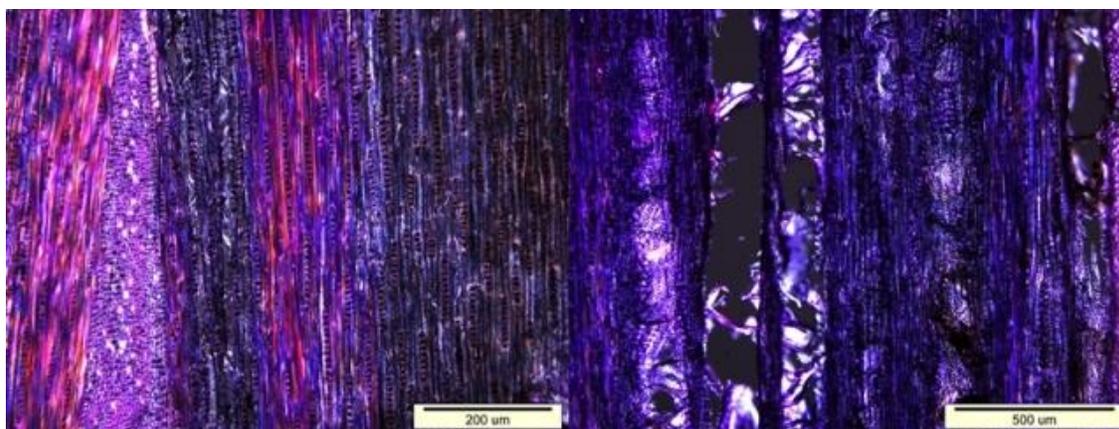
Fig. 9. Loss of birefringence (dark areas) in the longitudinal sections

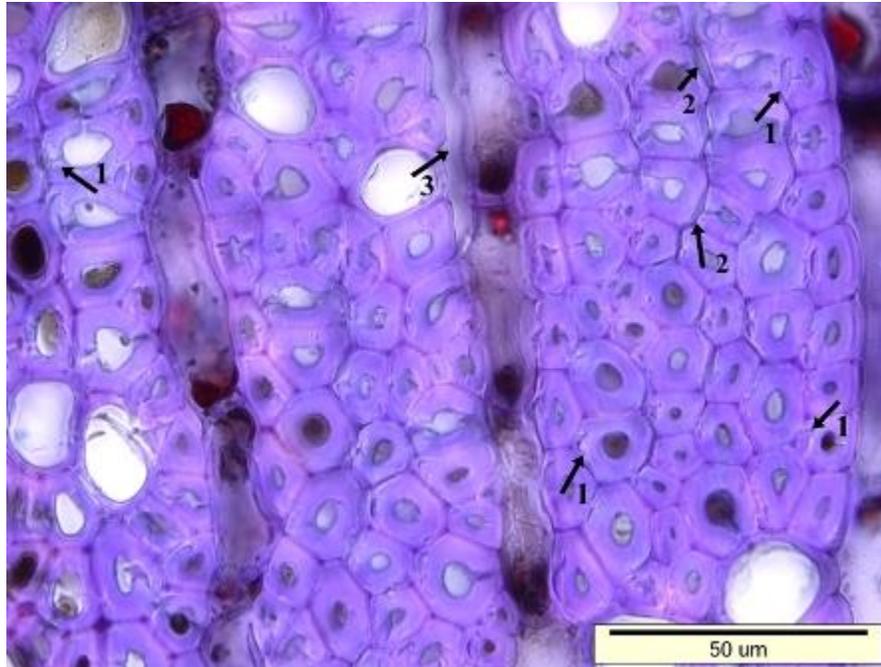
Fig. 10. Typical degradation patterns for white-rot decay: Splits in the cell walls of the fibers (1), separations in-between the fiber cells (2), and in-between the fiber-ray parenchyma cells (3)

In contrast, splits in the cell walls of the fibers as well as separations between the fiber cells and the fiber-ray parenchyma cells were observed in fewer quantities (Fig. 10). This type of degradation is common for white-rot decay (Wilcox 1968; Highley and Murmanis 1987; Schwarze 1995; Anagnost 1998; Luna *et al.* 2004).

There were different degradation patterns for brown-rot decay, such as cavity formation in the cell walls, extensive degradation of cell walls including the lignin-rich middle lamella, and degradation of the cell corners and middle lamella (Highley *et al.* 1985; Eriksson *et al.* 1990; Kim *et al.* 2000; Lee *et al.* 2004; Cho *et al.* 2008). These degradation patterns were reported as normal for white-rot decay.

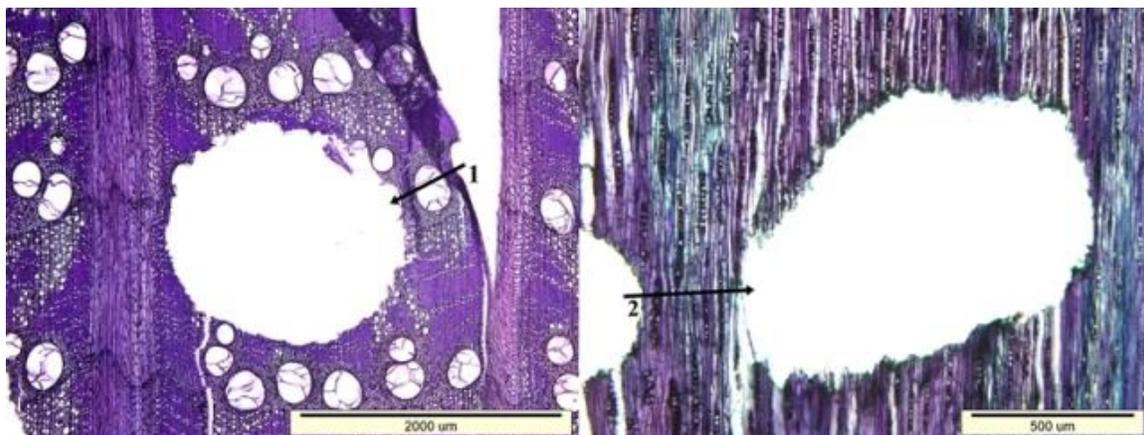
Fig. 11. Insect bore holes extending in the longitudinal (1) and transversal direction (2) of wood

Although the wood sample had been used as a construction element for several centuries, the macroscopic and microscopic examination revealed that it was in better condition than originally expected. The use of a very durable wood species, such as oak, in combination with the environmental parameters (especially unknown moisture and temperature history) played a role in the good condition of the wooden element. The white oak group species are characterized by highly durable heartwood due to the large content of tannins that act as fungicides and insecticides (Gambetta and Orlandi 1982). However, when wood decay began, what had happened through the time period is an important question with answers still unknown. Although the climatic conditions were rather favorable for insect and/or fungal activity in Metèora, the biological degradation of the timber element was prevented because the wood material was in the interior side of a balcony that was fully covered by a roof.

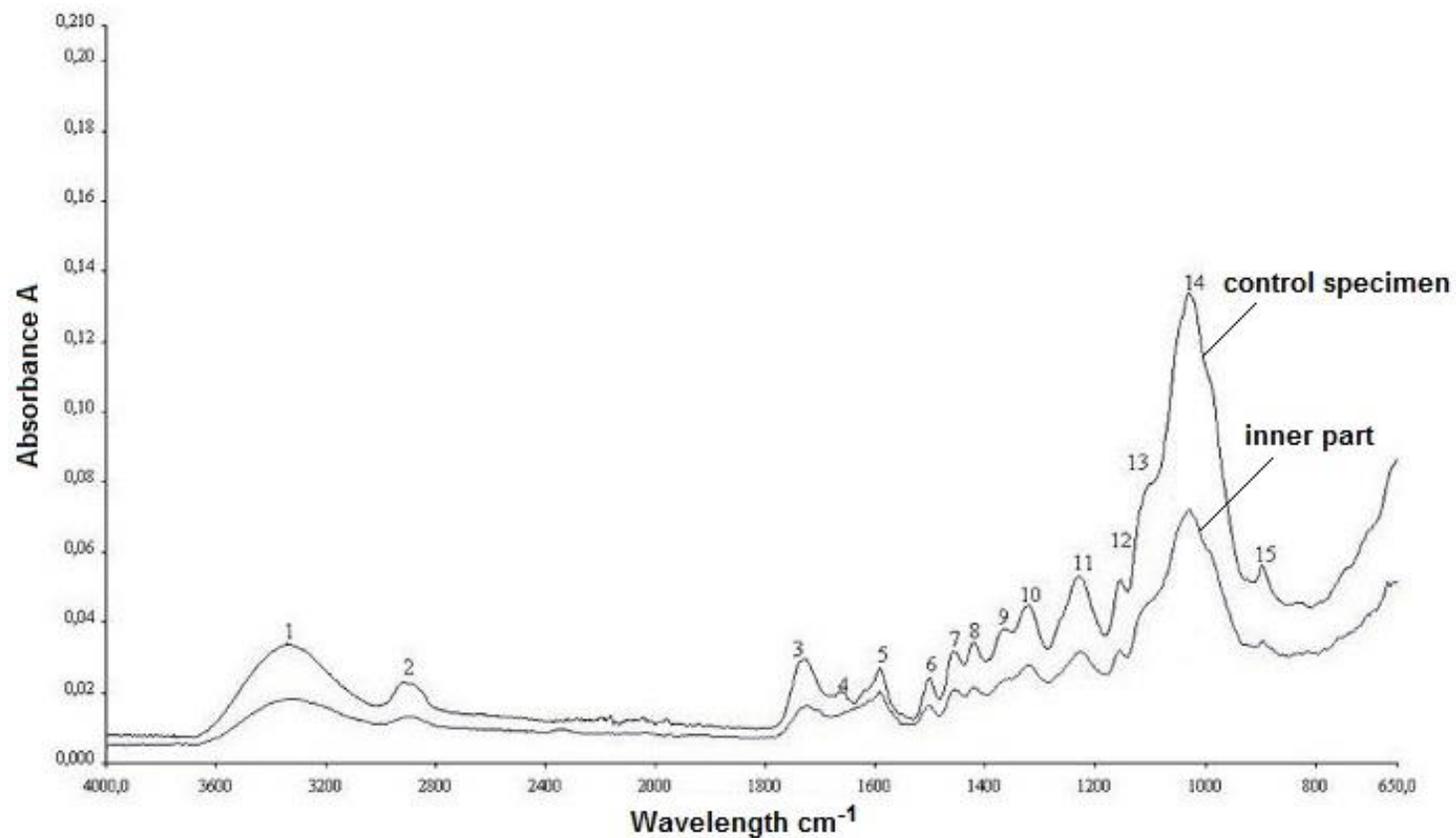
Fig. 12. The IR spectra of control sample and old oak wood sample (inner part)

The FTIR spectra of the control oak sample and the old wood sample are shown in Fig. 12. The old sample came from the inner part of the element that was exposed to several biological attacks. The explanations of the control wood peaks are presented in Table 1. The peaks were defined with reference to previous literature (Harrington *et al.* 1964; Faix 1991; Pandey and Pitman 2003; Schwanninger *et al.* 2004; Naumann *et al.* 2005). Some differences were observed in the bands of the spectra in this work as compared with the literature. To evaluate the degradation and weathering behaviour of historical oak wood, the surface layer of the sample was separated, and then examined. The spectrums taken from the old sample (inner part and surface layer), and the control sample can be comparatively seen in Fig. 13.

A strong hydrogen bond (O-H) stretching absorption was seen at 3332 cm^{-1} (1) and a next C-H stretching absorption was observed at 2919 cm^{-1} (2). As shown in Fig. 12, there were no considerable differences between the spectra for the control and old wood (inner part) samples in the fingerprint region. The most important difference was observed in the band at 1648 cm^{-1} . While it was seen in the control sample, it disappeared in the old wood sample. The absorption band at 1648 cm^{-1} may have been suppressed by a strong absorption at 1592 cm^{-1} , which was the next spectrum and indicated an important amount of lignin presence in the old oak sample. Because the specimens came from a hardwood, the lignin type was of the guaiacyl-syringyl type; thus, it gave noticeable peak absorbance at 1590 cm^{-1} besides 1502 cm^{-1} , as can be seen in Fig. 12. The syringyl-type of lignin, which is characteristic for hardwoods, absorbs only at 1230 cm^{-1} (Sarkanen *et al.* 1967), while both the control and old wood specimens had a remarkable absorbance at 1228 cm^{-1} , a result that was slightly different from the literature (Fig. 12). Furthermore, it was detected that the band at 1590 cm^{-1} in the control sample shifted to 1592 cm^{-1} in the old sample (Fig. 12). But the intensity at 1502 cm^{-1} that represented the aromatic skeletal vibration in lignin was kept in the same level, as can be seen in Fig. 12.

Remarkable decreases were observed in the intensities at 1729 cm^{-1} (3), 1365 cm^{-1} (9), 1152 cm^{-1} (12), and 895 cm^{-1} (15). All of these peaks were derived from the polysaccharides in the wood. Besides, the band at 1730 cm^{-1} shifted to 1722 cm^{-1} , and the band at 1367 cm^{-1} shifted to 1362 cm^{-1} in the old wood when compared to the control (Fig. 12). Even though there was no considerable visible difference between the two wood samples as shown in Table 1 and Fig. 12. However, there were some important differences between the maximum peak heights of the spectrums between the control and old sample. Table 2 lists the ratios, which obtained the lignin peak height at 1502 cm^{-1} , that were ratioed against the carbohydrates reference peaks' intensities. While 1730 cm^{-1} , 1367 cm^{-1} , 1155 cm^{-1} , and 895 cm^{-1} were the reference peaks for carbohydrates in the control wood, 1722 cm^{-1} , 1362 cm^{-1} , 1155 cm^{-1} , and 895 cm^{-1} were the reference peaks for carbohydrates in the old wood. Because the bands at 1730 cm^{-1} and 1367 cm^{-1} in the control wood were shifted to the band at 1722 cm^{-1} and 1362 cm^{-1} in the old wood, respectively the control and old wood band intensities were taken separately for those bands.

Therefore, it was apparent that the carbohydrates especially polyoses, in the old sample, were subjected to degradation through the years, while the lignin was found to be more stable (Table 1 and Fig. 12). This type of degradation probably occurred *via* brown rot fungi. Notably, the IR findings were consistent with the anatomical observations. Moreover, the decay progress seemed to be very slow; otherwise, the cellulose in the old wood sample would have been depolymerised in a more rapid rate (Kim *et al.* 2000).

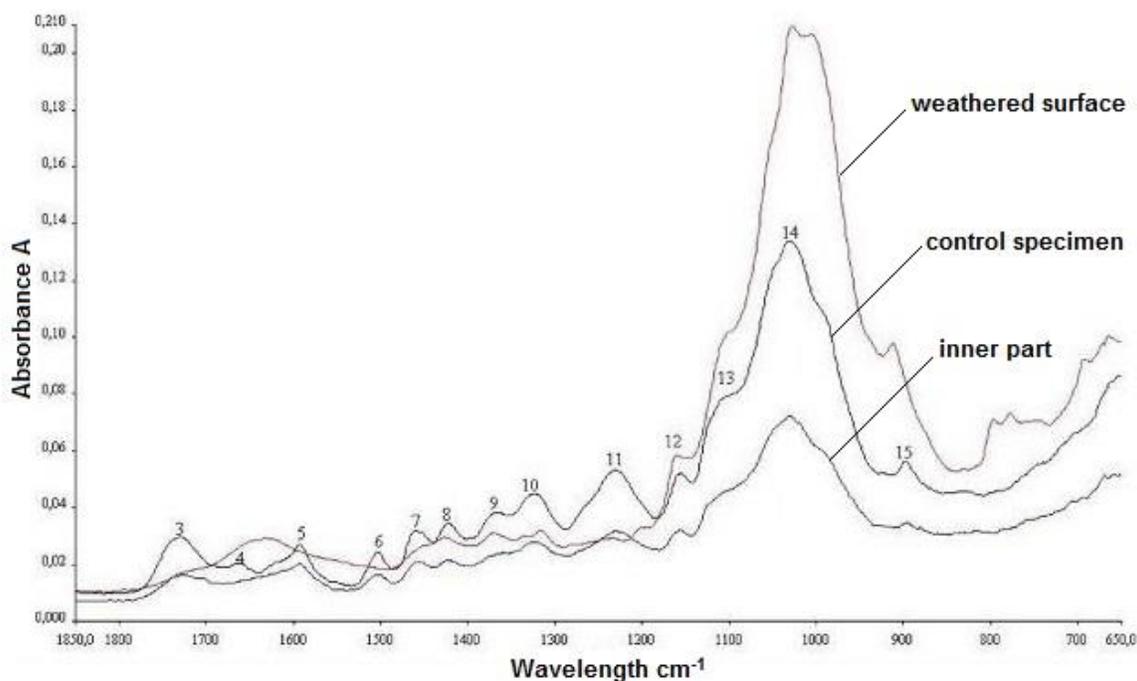
Fig. 13. The IR spectra of the control sample, inner, and surface layers of old oak sample

The IR spectra of the control sample and the old wood sample (both from the inner part and surface layer) are depicted in Fig. 13. As expected, the degradation in the surface layer of the old oak specimen was realized in a much higher degree when compared with the inner part of the sample. The peaks at 1590 cm^{-1} , 1502 cm^{-1} , 1453 cm^{-1} , and 1228 cm^{-1} , which refer to lignin, disappeared due to the detrimental effects of outdoor parameters, mainly UV light. Additionally, the most apparent change was observed in the band at 1730 cm^{-1} , which indicated C=O stretching in the xylans. While the band at 1730 cm^{-1} completely vanished, the intensities of the bands at 1423 cm^{-1} and 1322 cm^{-1} were largely decreased. In contrast, the bands that refer to cellulose (peaks at 1155 cm^{-1} , 1107 cm^{-1} , 1026 cm^{-1} , and 895 cm^{-1}) were observed and kept their existence at the same wavelength.

According to the IR results, the decomposition and modifications in the bands related to the polysaccharides were very clear when compared with the characteristic lignin bands, for the inner part of the old wood sample. Because the old oak material was used as a construction element for some centuries, the weathering effects were more severe.
