***Repair and conservation
of old wooden constructions
and furniture at TEI Larissa - Greece
Education and activities***

***Dept. of Wood & Furniture Design & Technology
Tech. Edu. Inst. of Larissa - Greece***

Study of the Meteora wooden constructions by N. Paggitoulis and I. Kakaras

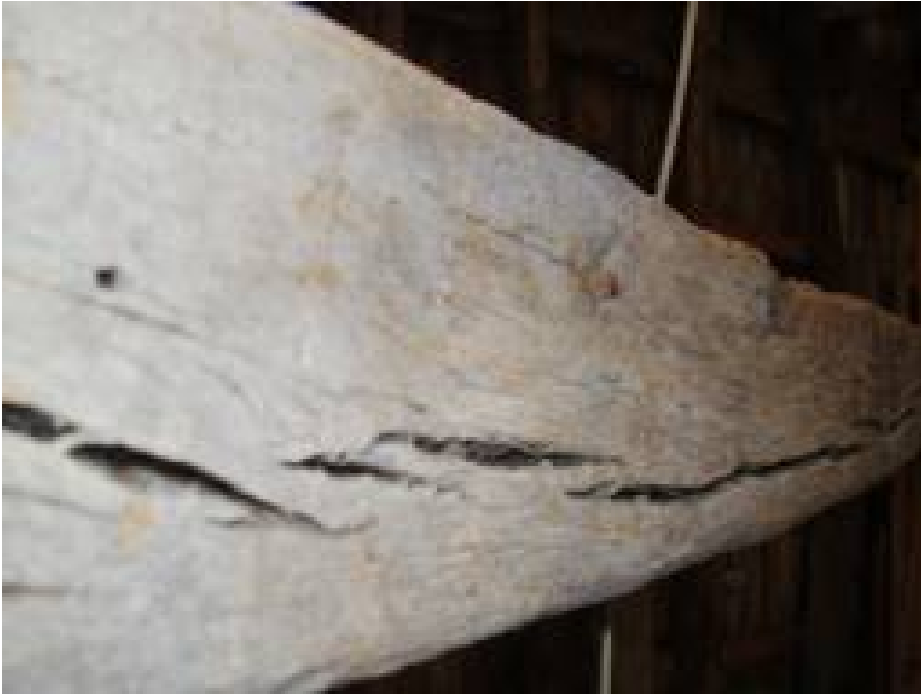
Large longitudinal checks on a wooden element (15th-16th century)

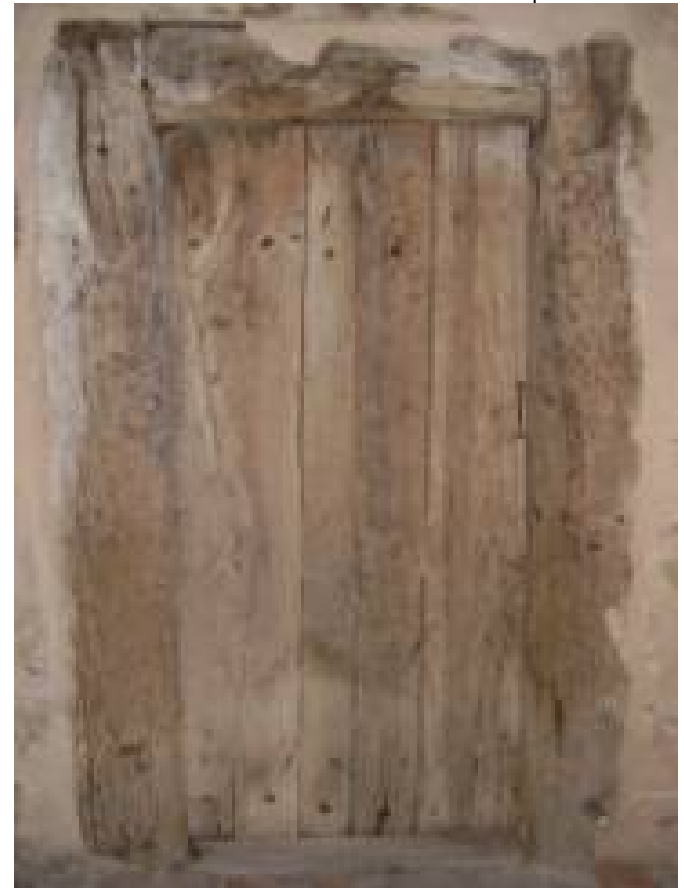
Oakwood door that needs conservation

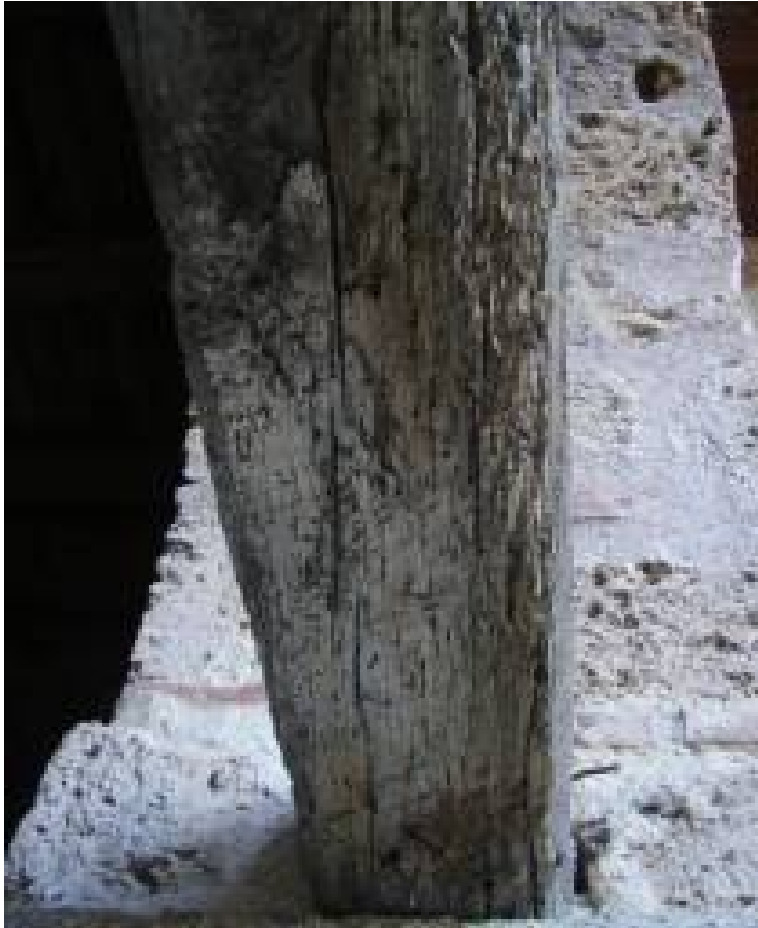
- The degradation is serious, but is limited to a surface layer of 5-15 mm. Suggested actions is first the **removal of the rotted layer** and then **a preservative treatment + oil treatment** and finishing work.

All kinds of surface degradation on a wooden column (fungi attack, wormholes, checks and weathering degradation).

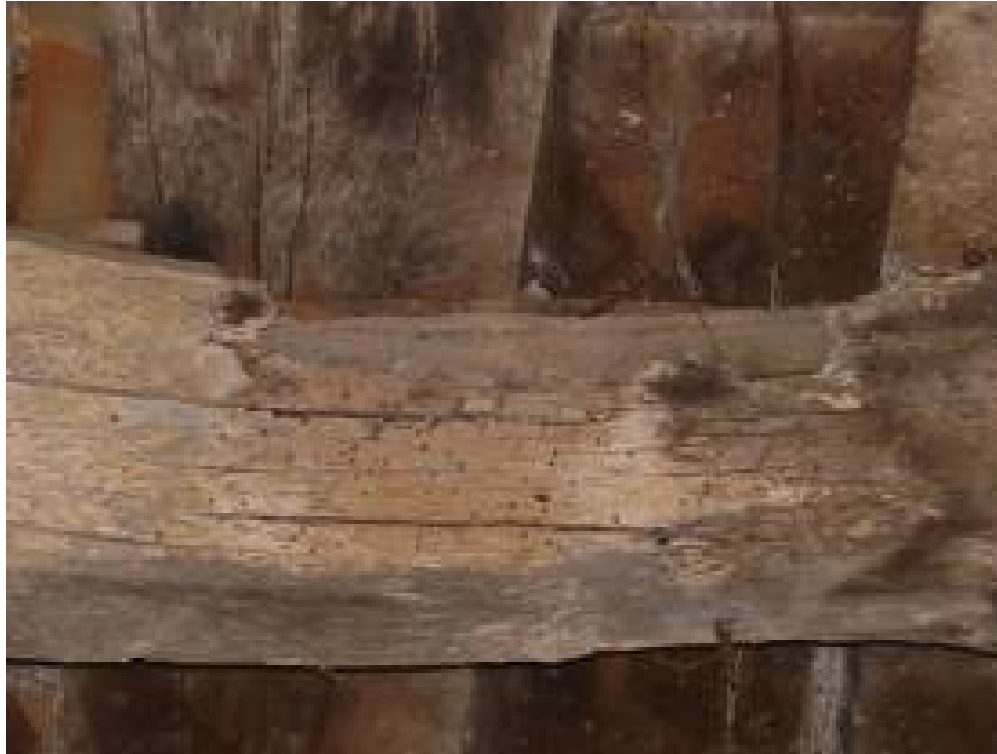
Rot and wormholes on the surface layer of an Oak structural element.
